VERMILLION CARNEGIE LIBRARY HISTORIC PRESERVATION PLAN

The City of Vermillion, South Dakota

June 2023

**Michelle L. Dennis
M.L. Dennis Historic Preservation Consulting
Rapid City, SD**

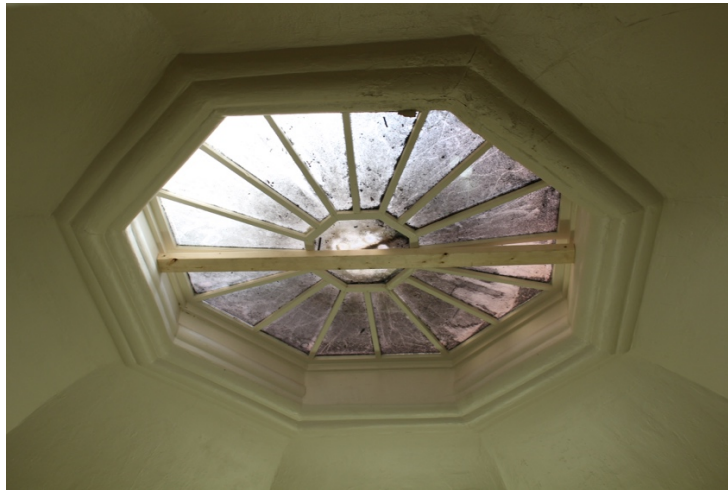
- Dome and cupola – according to City staff, the cupola leaks and water infiltration is contributing to the deterioration of the wood members which hold and frame the glass skylight; the lower portion of the dome is covered with a roofing membrane material making it impossible to visually inspect the condition of the dome/roof connection, which may also be deteriorated

The skylight in the cupola

1. Repair Cupola – To stabilize this character-defining feature, the City should consult with a contractor who can evaluate where the water infiltration is occurring and can make repairs accordingly. It may be necessary to fabricate the wooden framework for the “skylight” window and replace glass components are needed.

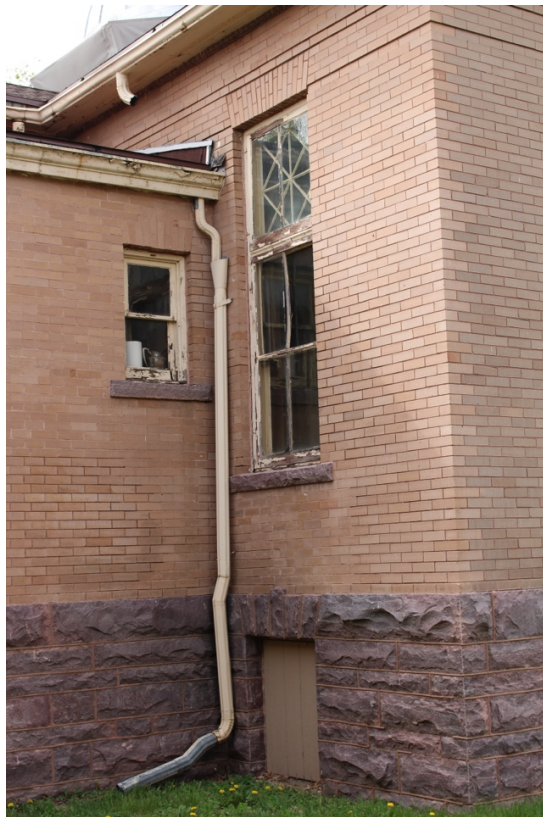
- Rain gutters and downspouts – they appear to be worn and not properly attached in some areas, allowing for rainwater to run between the roof edge and the gutter, or they do not direct or carry away from the building appropriately; there are no gutters on the roof of the south entrance addition – the slope of this roof directs water directly into the stairwell and into the basement, as does the downspout from the roof of the southeast corner portion of the building where the downspout is dumping water directly against the east wall where it runs into the basement

Downspout allows for water the enter building along the foundation

Ideally, replacement of the existing gutters and downspouts should occur prior to the time that the roof is replaced. Their current condition is contributing to the on-going deterioration where leakage or moisture build-up has been observed in some areas. When they are replaced, care should be taken to have them properly attached to the roof edge and the downspouts should be directed away from the building.

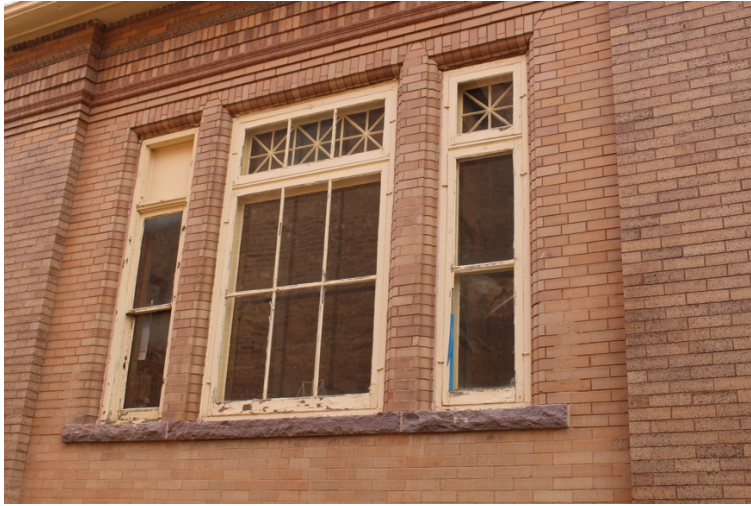
- Storm windows – are deteriorated with peeling paint and some rotten wood damage
- Interior windows – some of the glass is missing and there are a couple places where the exterior side of the window is deteriorated; most need paint on the exterior side

Example of deteriorated storm windows showing need for paint and repair

2. Windows – On the main floor, the historic interior windows can be repaired. In a few places, broken or missing glass needs to be replaced; there may be a few places where the wood sashes or framing or muntins may need to be repaired or replaced. The historic finishes on the inside of the windows should be retained; the painted finishes on the outside of the windows should be repainted. The exterior storm windows need to be repaired (if possible) or replaced. Most are in a deteriorated state and have not been well maintained. Where possible, repairs should be made. Where repairs are not possible, replacement in-kind should be considered. If in-kind replacement is not possible, replacement with a substitute material may be considered as long as the material will match the original in design, color, and texture. The windows in the basement need to be evaluated further. It is possible that some of them can be repaired and provide a proper seal from leakage; it is also possible that some may be in such condition as to require replacement.

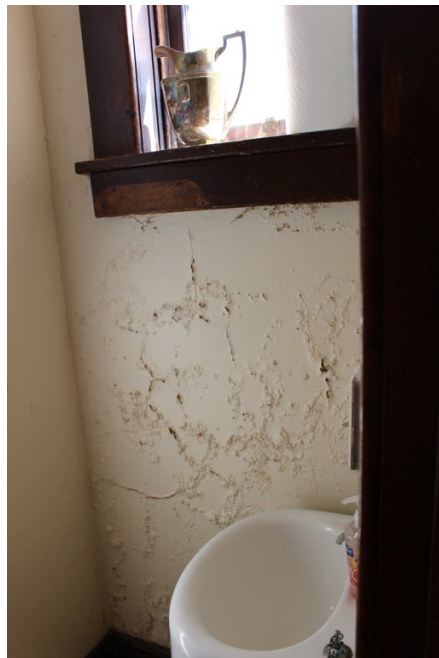
- Front entry steps – are cracked and breaking apart, creating possible trip hazards
- Front entry flooring – the original ceramic tile is cracked and loose
- Plaster walls on the main level – areas of cracking, peeling, and deterioration (possibly from water infiltration in the restroom and storage room on the south side of the building)

Plaster damage in restroom

3. Interior Wall Repairs – There are some locations on the main level where the plaster walls have been damaged by water infiltration. These areas should be repaired and replastered, once the water infiltration problem is solved. Replastering is not always possible, so a suitable alternative may be considered and an effort should be made to match the texture of the surrounding historic plaster so the repaired area blends well with the historic area.

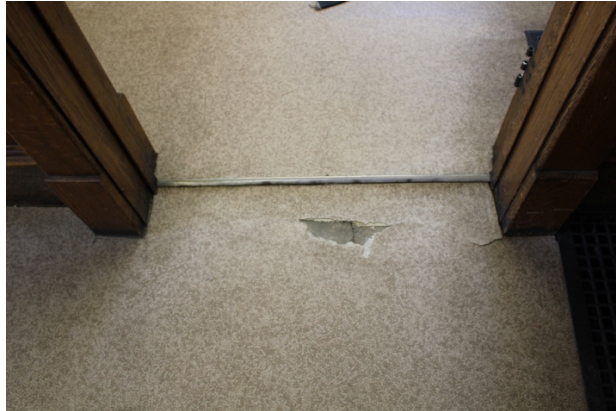
- Ceilings – there are a few missing pieces of the acoustic tile
- Floors – the original wood floors (main level) appear to be intact beneath the sheet linoleum that has been applied in some of the rooms, but is wearing and cracked and missing in some areas

Cracked and chipped flooring

- d. Flooring – As time and money permit, the sheet linoleum on the main level should be removed and the historic wood floors refinished. Where the wood flooring was removed, new wood flooring may be installed. In areas where the original flooring may have been something other than a finished wood, an attempt to repair or replace the flooring should be made.

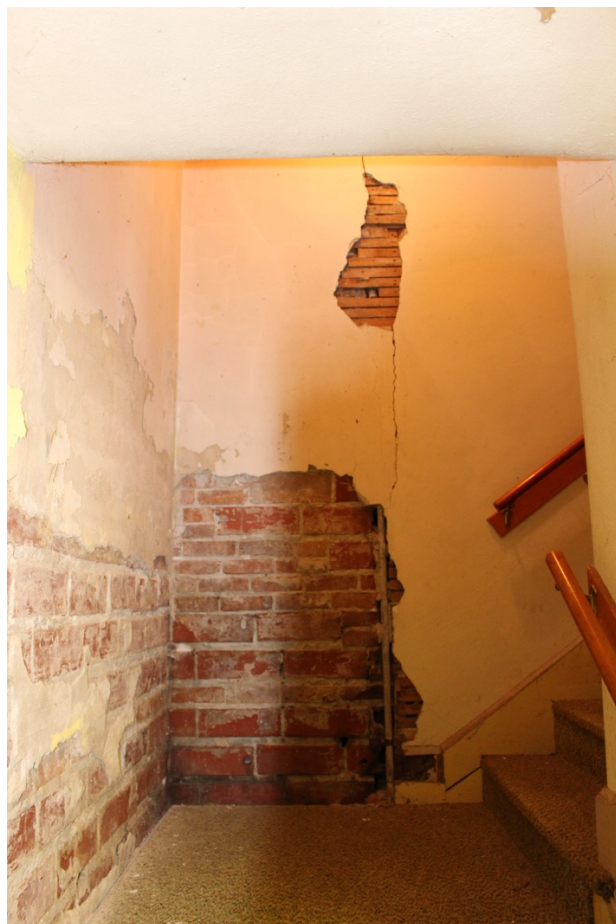
- Stairs to the basement – sections of plaster are missing, exposing the brick and tile walls

Areas of cracked and missing plaster in stairwell to basement

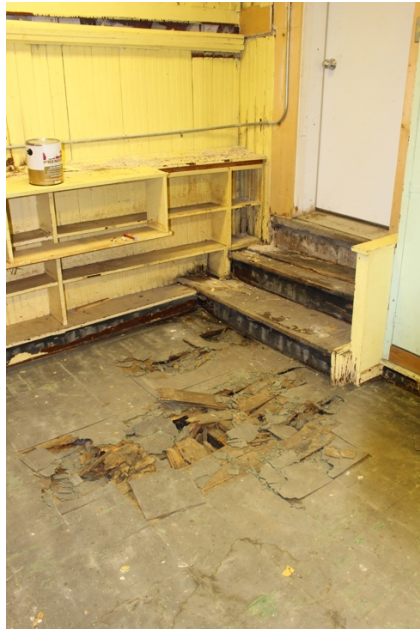
- Basement – walls, ceilings, and floors are in various states of disrepair and deterioration; the floor at the bottom of the steps to the south side entrance is severely deteriorated and has developed holes through the floor structure making it unsafe to step into that part of the room; walls around windows are cracked, some with evidence of water infiltration

Damage to floor at south entrance

Once the water issues are resolved, plans can be made to repair and rehabilitate the basement walls, ceilings and flooring. At the top of that list is the repair of the hole in the floor at the bottom of the stairs at the east entrance. Not only is this area extremely hazardous, failure to repair it will result in further deterioration of the floor.

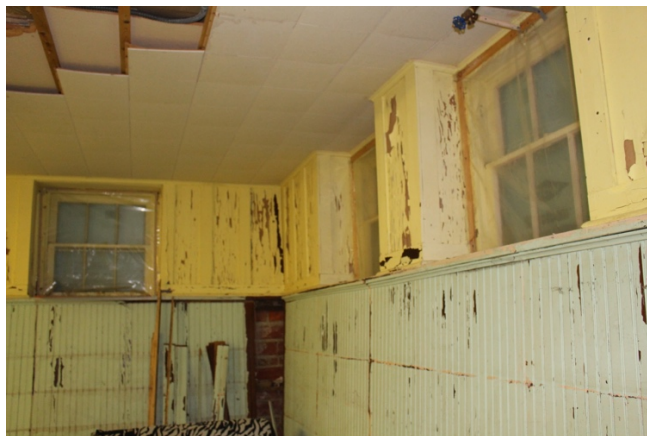
Old Children's Library in southwest corner of basement;
photo shows condition of walls and ceiling

- e. Basement – The single most important thing to attend to in the basement is the resolution of the water infiltration issues. Some of the issues may be resolved with improved landscaping and/or the installation of new gutters and drains to direct water away from the building. If it is determined that a part of the problem is being caused by leakage around and through the historic windows (as suggested in the 2015 Banner Associates report), it may be necessary to repair/replace the windows and their framing to create an appropriate water-tight seal.
